DEFENSE CONTRACT MANAGEMENT AGENCY
DEFENSE CONTRACT MANAGEMENT AGENCY INTERNATIONAL
6359 Walker Lane, Suite 220
Alexandria, Virginia 22310-3259

CAR # HQ-08-LOGCAP-001 LIII

Deficient Quality System - Level III Corrective Action Request

SPECIFIC FINDING #1- GROUNDING and BONDING

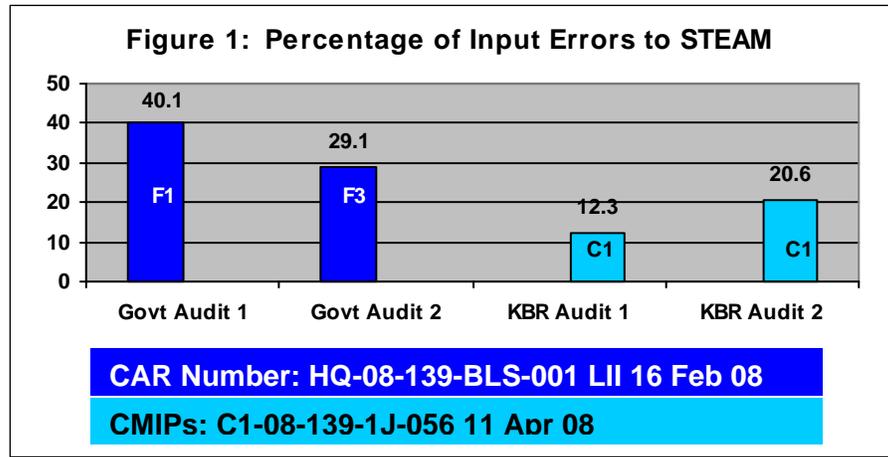
Figure 1 shows the percentage of erroneous data inputs into the STEAM system documented by Government and KBR Quality Assurance. Erroneous inputs include: Wrong work priority categorization, incorrect job start and stop times, incomplete work orders, etc

At site F1, an initial input error rate of 40.1% was recorded. A subsequent audit at F3 returned an error rate of 29.1%. With these results, the Government issued CAR HQ-08-139-BLS-001 LII. KBR Quality performed two audits at site C1 following implementation of KBR’s Corrective Action plan which showed 12.33% and 20.6% error rates after the issuance of the CAR.

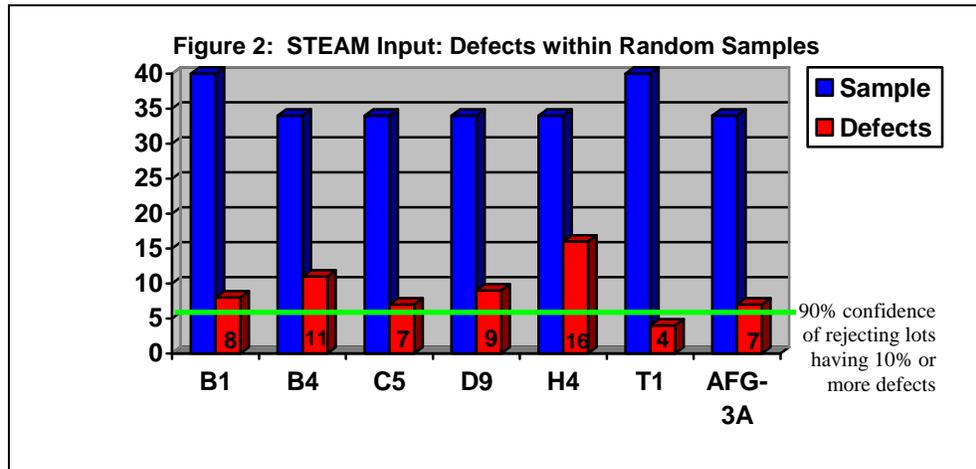
The Government conducted a subsequent review of SORs in the STEAM system on 30 Aug 08 utilizing a statistical double sampling plan that discovers defects of 10% or more, if they exist 90% of the time. Electrical SORs from seven sites for the period of 01 Aug 07 to 31 July 08 were sampled. Sites selected for review were: B1, B4, C5, D9, H4, AFG-3A, and T1. In order to determine which SORs to review, a random number generator was used. A total of 250 Priority 1-3 samples were reviewed with 62 defects identified. All lots sampled but one (T1) sampled failed the first pass. The second pass on T1 found 7 defects and the lot was rejected. These failures indicate this is a Program-wide nonconforming condition for electrical SORs and likely for others as well. As shown in Figure 2, “Steam Input: Defects within Random Samples,” the

overall average error input rate for sites surveyed was 24.8% and mirrors previous findings by KBR at site F3 in Apr 2008.

Figure 2, Steam Input: Defects within Random Samples, the overall average error input rate for all sites surveyed was 24.8% and mirrors previous findings by KBR at site F3 in Apr 2008.

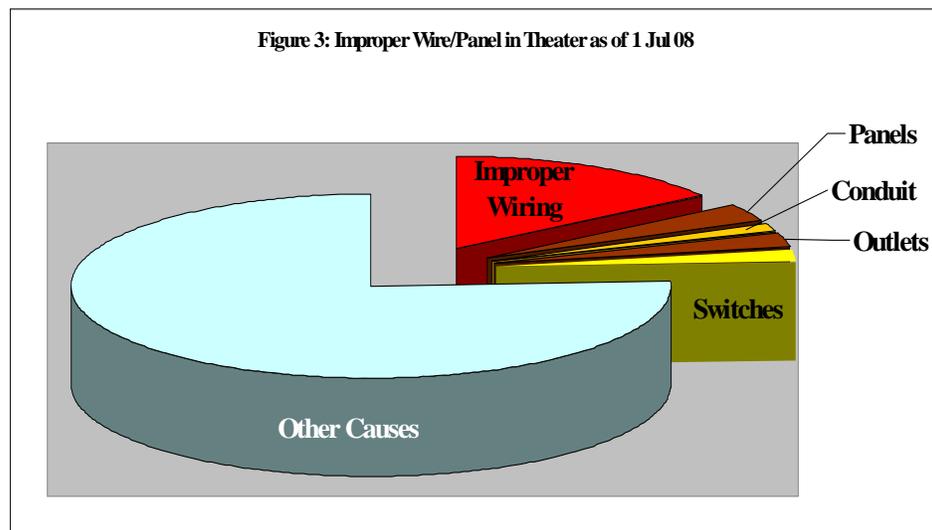
- A. At the Government's request, KBR trended and provided data for the March through May 2008 fire hazard inspections conducted IAW T.O. 139 paragraph 8.19. KBR provided a *Fire and Emergency Services Deficiency Report* on 01 Jul 08 ([Attachment 33](#)) in response to this request. The report revealed that a total of 26,205 incidents of improper wiring were discovered during the fire hazard inspections. In addition to improper wiring, another 5,225 cases of errors with fuses and panel boxes, 2,285 incidents of conduit and raceway hazards, 4,571 incidents of outlet box hazards, and 3,201 incidents of hazardous switches and fuses were noted for a combined total of 41,487 electrical facility fire hazards. Across the theater, a total of 171,538 hazards were recorded in the report. Improper wiring and panel/fuse boxes account for 18.3% of the total hazards as shown in Figure 3.

Figure 3, Data obtained from KBR's Emergency Services Deficiency Report, shows 18.3% of all incidents are related to faulty electrical wiring or electrical distribution panels. The pale grey segment of the pie is composed of 122 additional causal categories contained in the report.

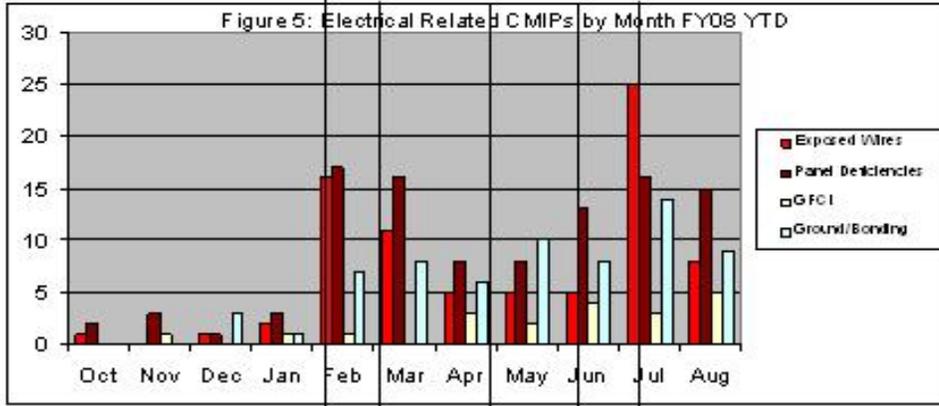
Electric Related CMIPs

376 CMIPs Reviewed

267 repeat (71% of 376)

16.78% of all CMIPs (17% of 1591)

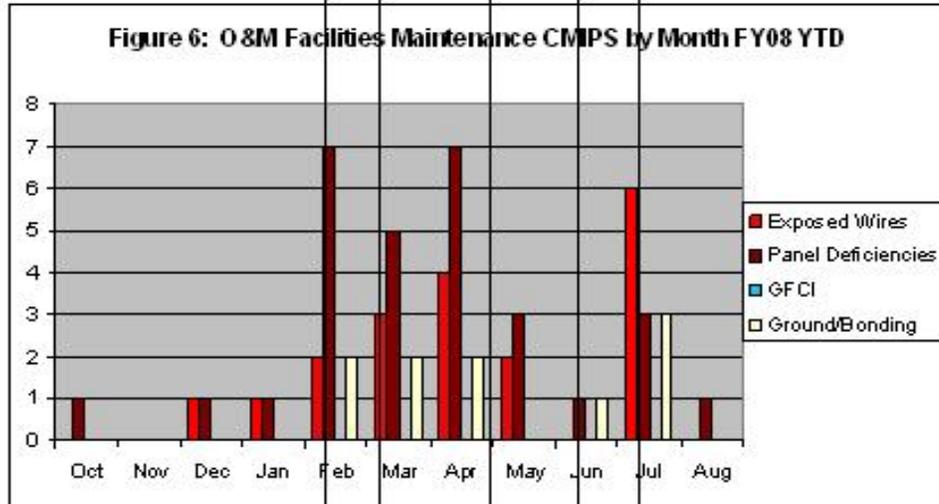
O/M and Fac Maintenance

145 CMIPs Reviewed

59 repeat (40.7% of 145)

3.7% of all CMIPs (3.7% of 1591)

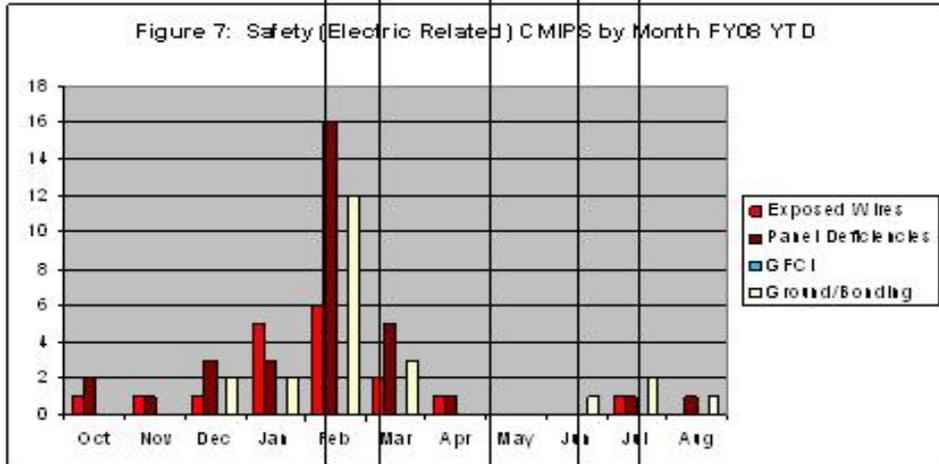
Safety

147 CMIPs Reviewed

74 repeat (50.3% of 147)

4.7% of all CMIPs (4.7% of 1591)

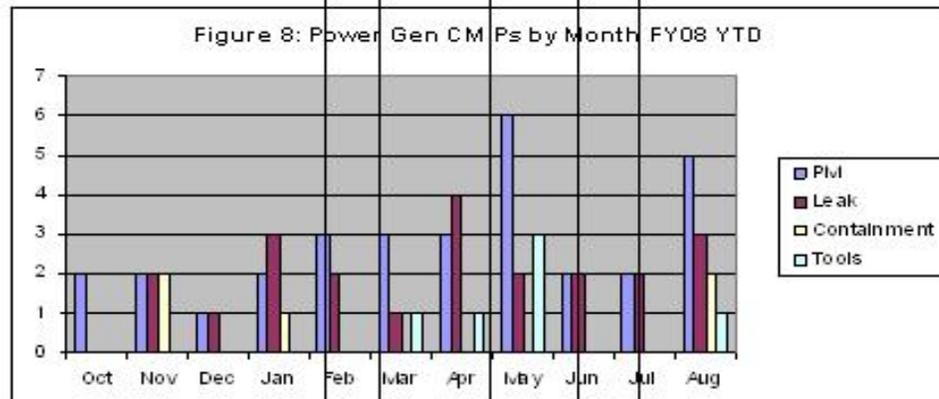
Power Gen

- d. Power Generation (Figure 8):
 - i. 143 CMIPs reviewed.
 - ii. 64 repeat CMIPs discovered (45% of 143).
 - e. Total repeat CMIPs: 464 or 29% of the total CMIP population. This is consistent with the repeat CMIP findings in the first sample.

143 CMIPs Reviewed
