**DEPARTMENT OF DEFENSE
OFFICE OF INSPECTOR GENERAL**

SUBJECT: Review of Electrocution Deaths in Iraq: Part II – Seventeen Incidents Apart
From Staff Sergeant Ryan D. Maseth, U.S. Army (Report No. IPO2009E001)

**Review of Electrocution Deaths in Iraq:
Part II – Seventeen Incidents Apart from
Staff Sergeant Ryan D. Maseth, U.S. Army
(Report No. IPO2009E001)**

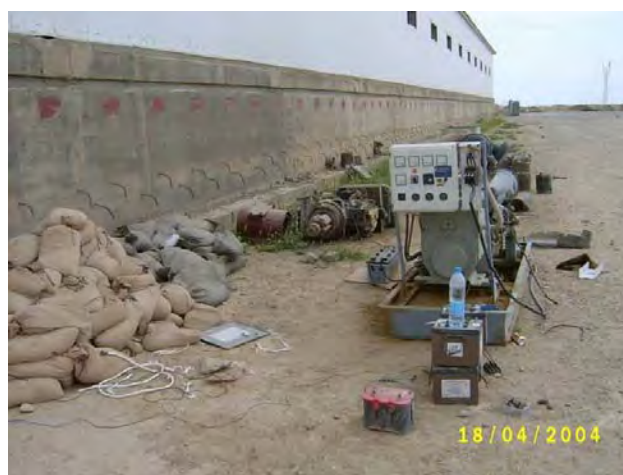
Specialist Marvin A. Campo-Siles was electrocuted while attempting a generator repair at Pad 9, Forward Operating Base Brassfield-Mora, Samarra, Iraq, on April 17, 2004. The generator and exterior of the housing unit involved in the incident are shown in the figure below.

**Figure 1. Generator and Housing Area
Involved in the Specialist Campo-Siles Electrocution
(From Army Photographs)**

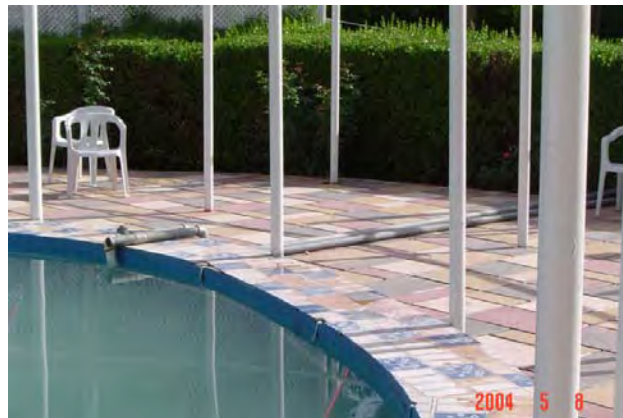
Specialist Chase R. Whitham was electrocuted while swimming in an outdoor pool at Forward Operating Base Patriot, Mosul, Iraq, on May 8, 2004. The site is shown in the figure below.

Figure 4. Pool Where Specialist Whitham was Electrocuted (From Navy Photographs)

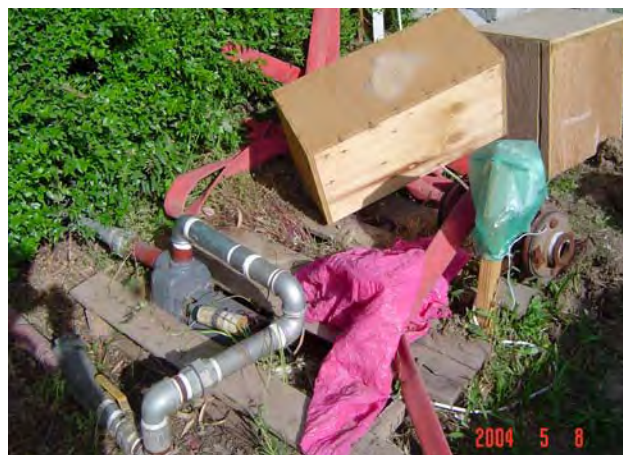
- **Water Pump:** The pump was located above ground, adjacent to a fuse box, and connected a water supply pipe, which continued to the pool, to a second above ground pipe, which also continued to the pool. The pipes were both 3-inch diameter metal pipes that extended about 20 feet through a hedge to the North swimming pool West side. Report of investigation photographs indicate boxes made of wood/lumber covered the pump and fuse box, as shown in the figure below.

**Figure 5. Covers for Pump and Fuse Box
in Area Where Specialist Whitham was Electrocuted
(From Navy Photographs)**

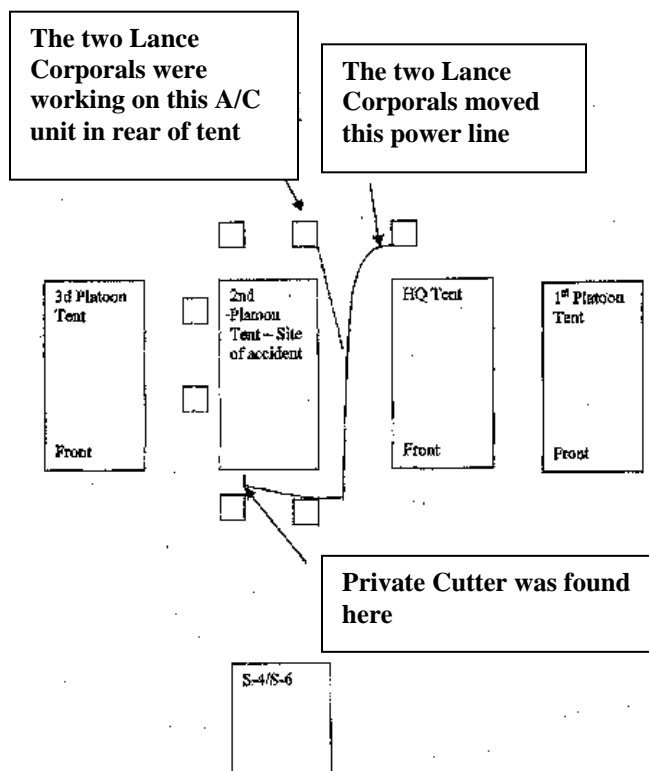
Private First Class Brian K. Cutter was electrocuted while attempting repair on an air conditioner unit at Al-Asad Airbase, Iraq, on May 13, 2004. The site is depicted in the figure below.

**Figure 6. Drawing Depicting Area Where Private Cutter was Electrocuted
(From Army Report of Investigation)**

Private First Class Cutter died from electrical shock while using a metal tool and attempting to rewire an air conditioning unit to the breaker box and subpanel/junction box. Resuscitation attempts were unsuccessful.

Further action is not warranted. Corrective action was taken against the noncommissioned officer who requested Private First Class Cutter repair the air conditioning unit.

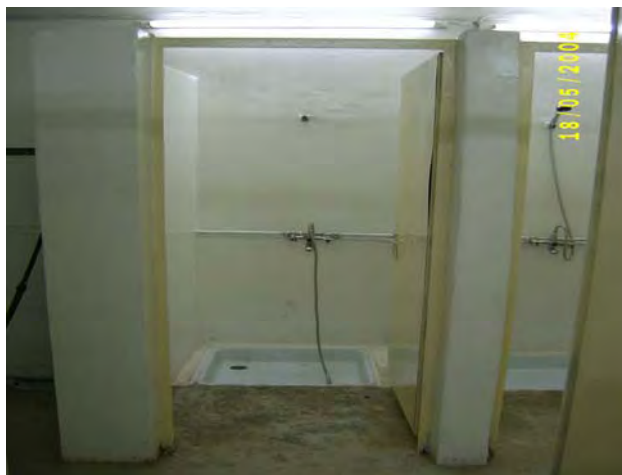
Specialist Marcus O. Nolasco was electrocuted while showering at Forward Operating Base Summerall, Bayji, Iraq, on May 18, 2004. The shower is shown in the figure below.

Figure 7. Shower Where Specialist Nolasco was Electrocuted (From Army Photographs)

(Note: An automatic water pump did not maintain water in water heaters, causing a heating element to rupture, resulting in electricity traveling through the metal water lines into the shower.)

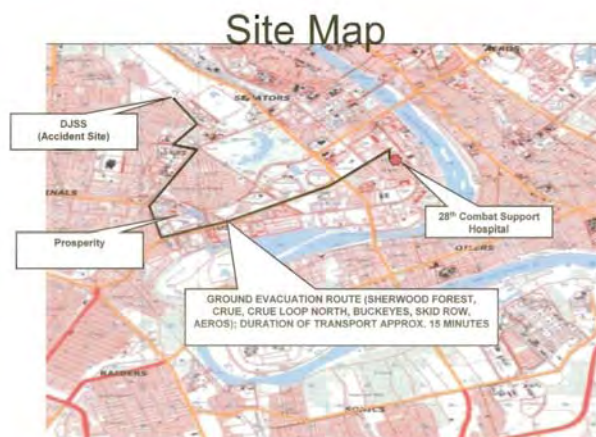
Figure 12. Site Map Showing Area Where Sergeant Montpetit Was Electrocuted (From Army Report of Investigation)
